EVALUATION OF SELECTED TREES AT

AT NORTHWEST UNIVERSITY

5520 108th Avenue NE
Kirkland, WA 98033

February 19, 2016

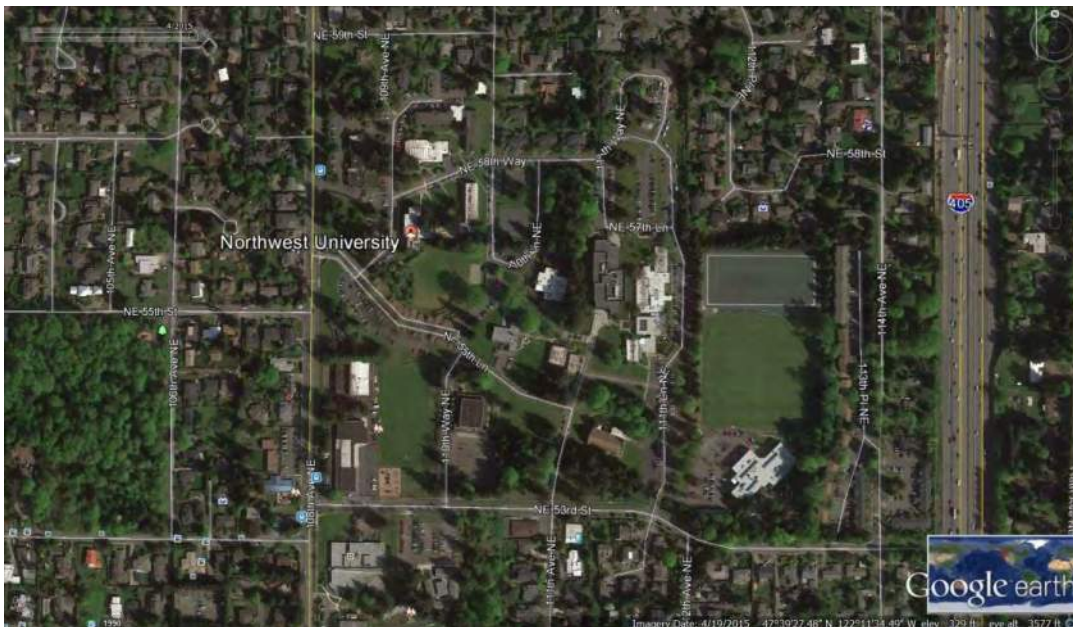
Photo # 1: A Google Earth image of Northwest University and the surrounding neighborhood. The large block of green forest east of 106th Ave NE is Carillon Woods Park. I-405 is to the east.

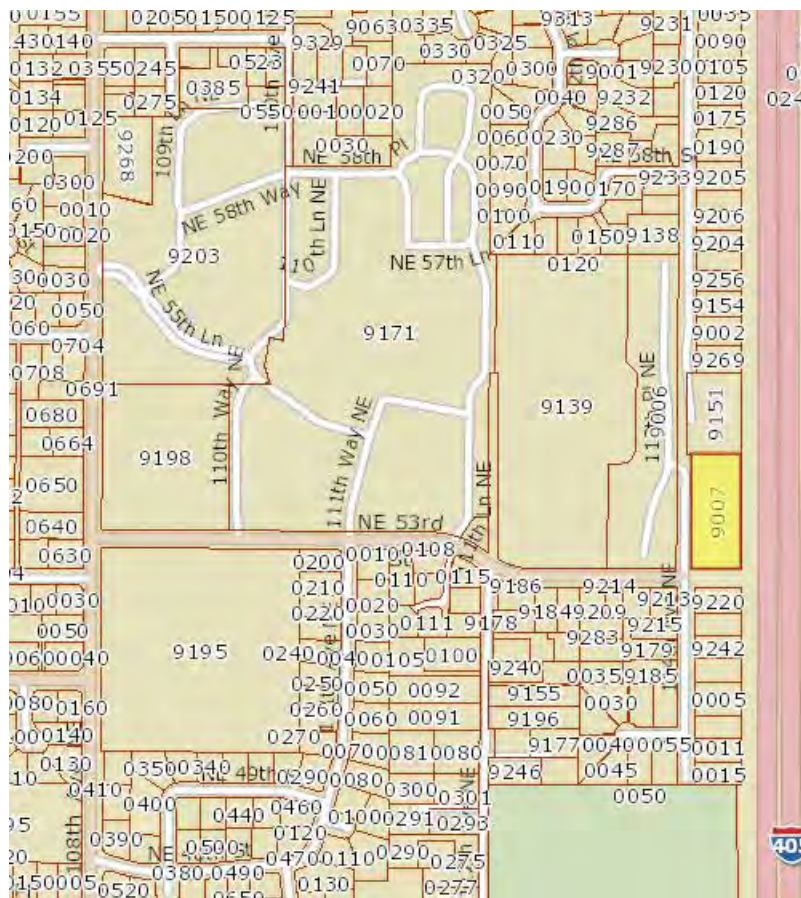
Photo # 2: This is a screen shot from the King County Assessor's web site.

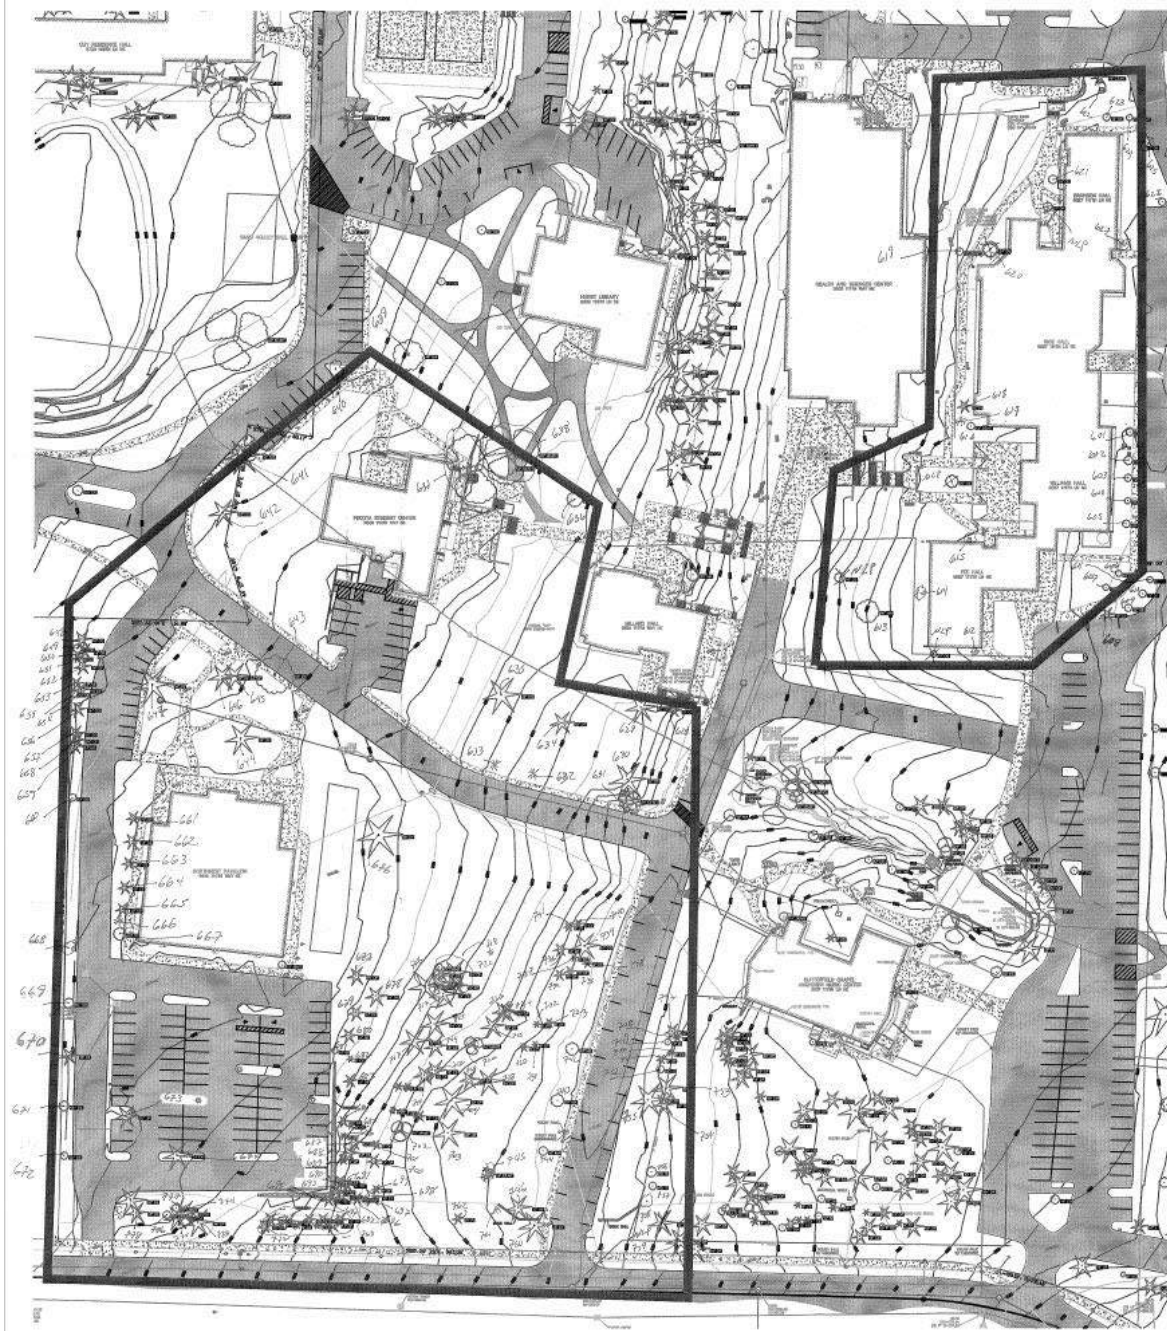
ATTACHMENT 1 - SITE SURVEY W/TREE #'S

In addition, there were a few trees shown on the site survey that are no longer present. In a few cases stumps were present. In a few cases there was no evidence remaining. Therefore, on *Attachment 1, Site Survey with Tree Numbers*, a red “X” was placed on the symbol with the letters, “NLP” written next to it. NLP stands for no longer present. I recommend that they be taken off the survey to avoid any potential confusion.

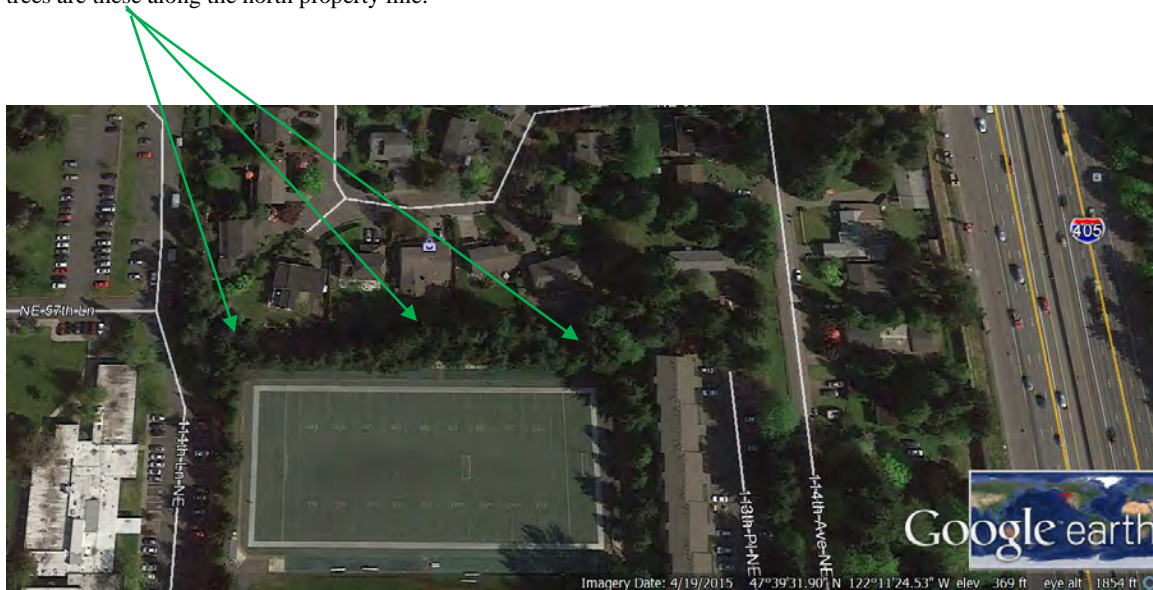
Photo # 2: A screen shot of a Google Earth image of the athletic field and the surrounding neighborhood. The row of trees are these along the north property line.
